## CASE STORY:

# 16 MONTHS OLD STALLED NEUROPATHIC FOOT ULCER ON A PATIENT WITH A HIGH COMORBIDITY

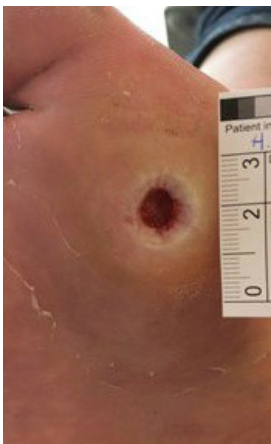
31st March 2016.

After debridement.

Some reduction visible after the first week of treatment.

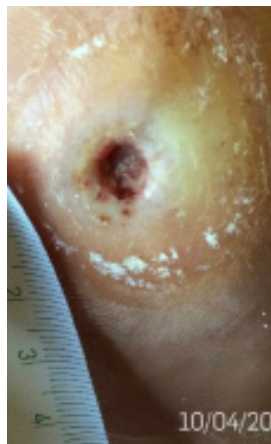
10th April 2016. Before (left) and after (right) debridement.

Wound surface had reduced. Procedure was continued.

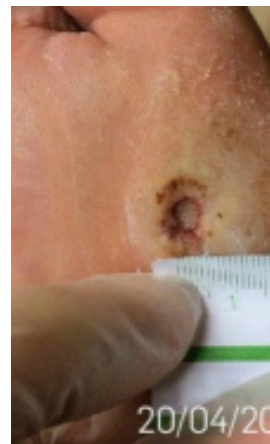
20th April 2016. Before (left) and after (right) debridement.

Less maceration. Good improvement. Procedure was continued.

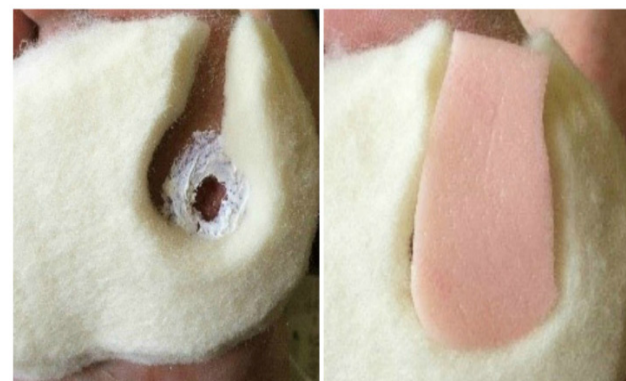
### PROCEDURE: OFF-LOADING IS IMPORTANT IN THE TREATMENT OF DFU'S

1. Felt used for off-loading
2. Wound edges protected and Woulgan applied in a thin layer
3. Wound covered with fibre dressing in several layers
4. Foam dressing applied on top
5. Fixated
